Inspection **Report**

Ms. Onah Holmes
123 Maple Street
Springfield, Ontario

Date: 2/6/2008	Time: 09:00 AM	Report ID: Sample
Property: 123 Maple Street Springfield Ontario	Customer: Ms. Onah Holmes	Real Estate Professional:

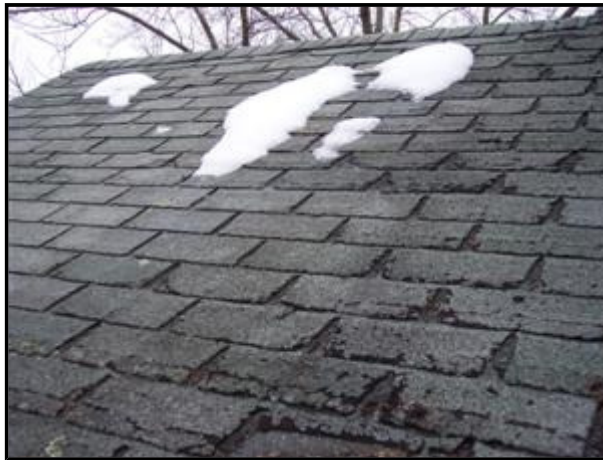
The roof shingles appear to be approximately 25-30 years old (Picture 1). Immediate replacement of roof coverings is recommended.

1.0 Picture 1 Shingles

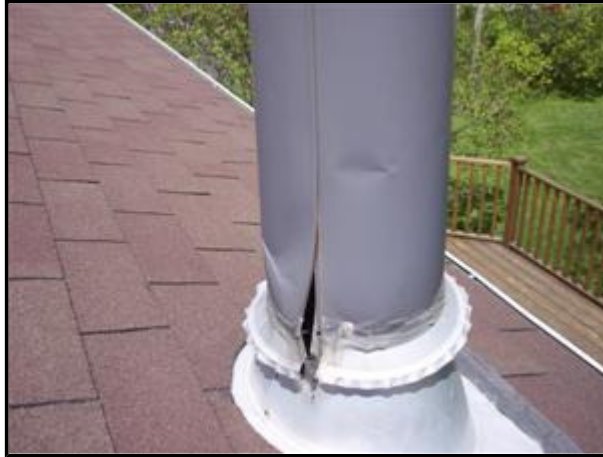
The outer shell of the factory built chimney serving the furnace has split along the seam (Picture 1 - next page). This could allow rain-water to penetrate the shell and degrade the insulation, leading to a fire hazard. Immediate replacement of the chimney is recommended.

1.2 Picture 1 Damaged chimney

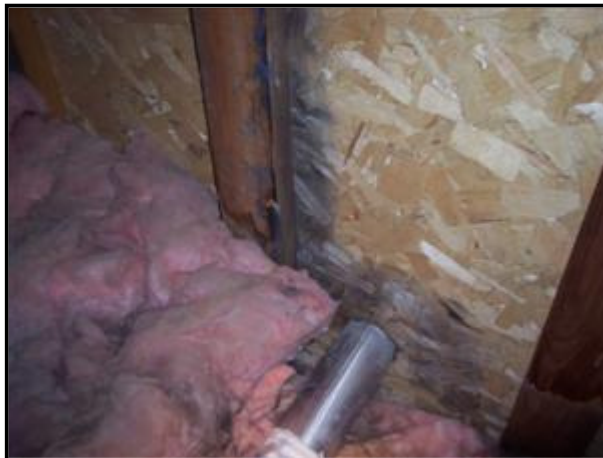
Water staining was noted on the attic gable wall in the vicinity of the bathroom exhaust duct (Picture 1 - below). This has likely been caused by leakage of warm, moist air from the duct or the fan casing which then forms condensation on cold surfaces. Consult with a qualified contractor to seal the duct and any penetrations in the fan casing and to caulk between the fan casing and the drywall ceiling.

1.4 Picture 1 Water staining at exhaust duct penetration in attic

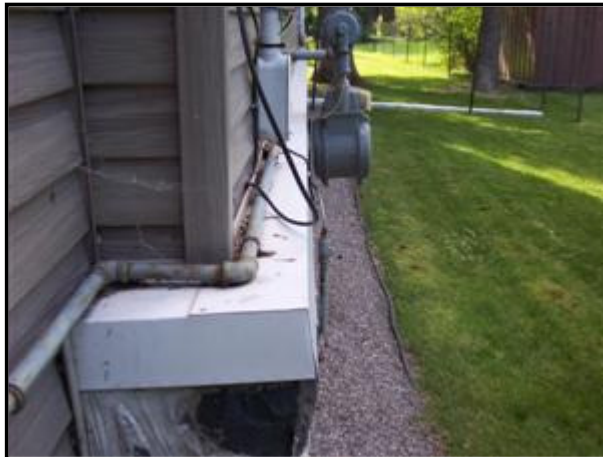
The flashing at the top of the foundation wall slopes back toward the house (Picture 1). This will direct rain-water into the wall structure. Consult with a qualified contractor to remove and re-install the flashing and inspect further for damage to the wood structure.

2.0 Picture 1 Flashing at top of foundation wall

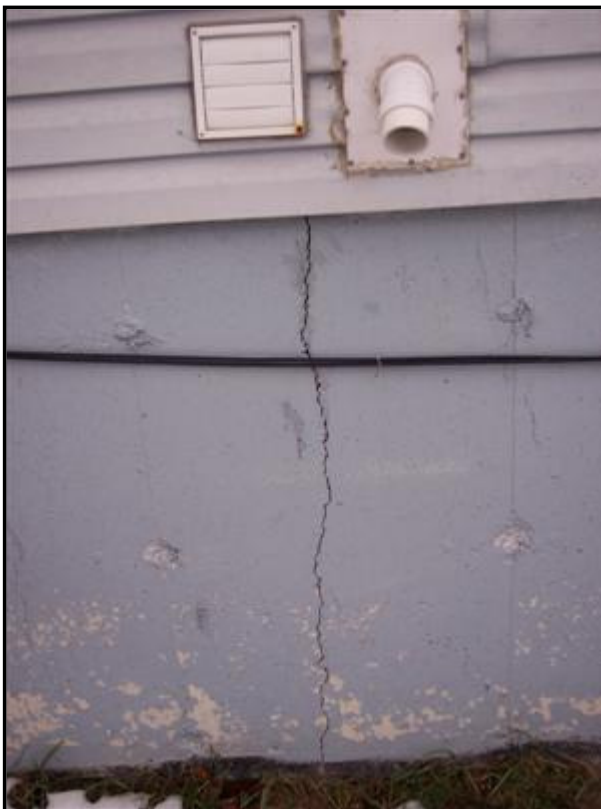
Crack noted at south side (Picture 1 next page). Monitor for signs of movement (shifting, spreading). Consult with a qualified masonry contractor to assess and repair, if necessary.

2.1 Picture 1 Crack at south side

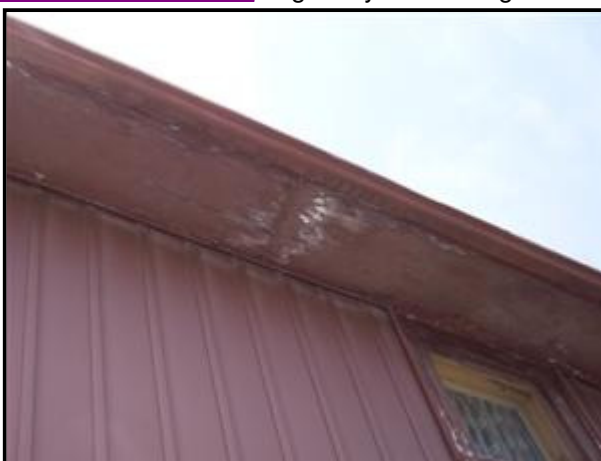
Water staining noted at east side (Picture 1 - below). Further investigation is required to determine the source of water. Likely causes include roof leaks caused by ice damming and condensation caused by moist air leaking from the house to the attic. See the attached article [Attic Venting, Attic Moisture and Ice Dams](#) to guide your investigation.

2.2 Picture 1 Water staining at soffits, south side

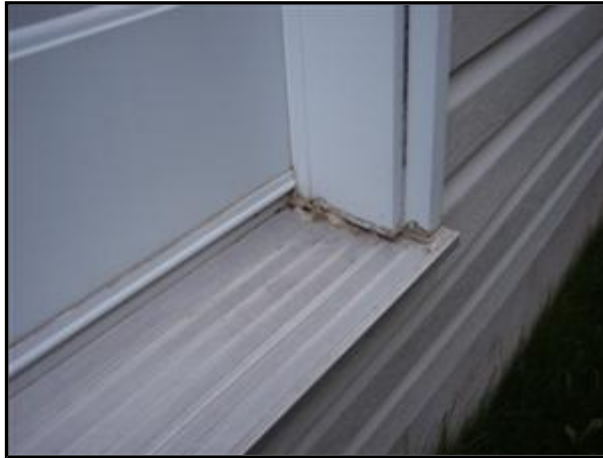
2.3 Picture 1

The caulking between the door jamb and the threshold at the west side has failed (Picture 1 - next page). This puts wood framing below the door at risk of water damage. Further

investigation by a qualified contractor is required to determine if significant damage has occurred. Remove and replace the existing caulking material with an exterior grade caulk. Monitor the condition of all exterior caulking.

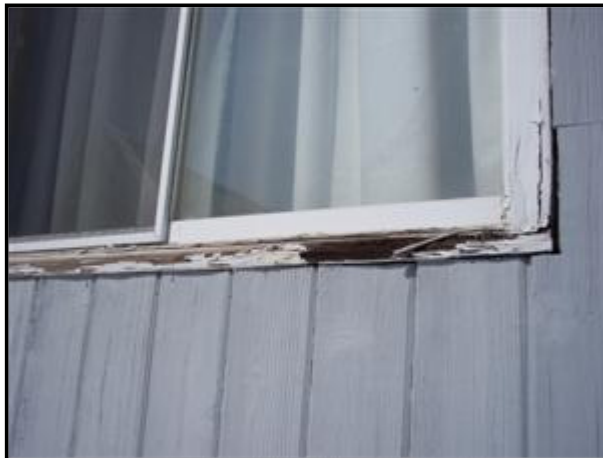
Some of the windows (south windows and east dormer) are water damaged (Picture 1 - below) and require immediate replacement to prevent water infiltration and damage to the surrounding structure. Some repairs to the wall structure may be required.

2.4 Picture 1 Water damaged window frame at south side

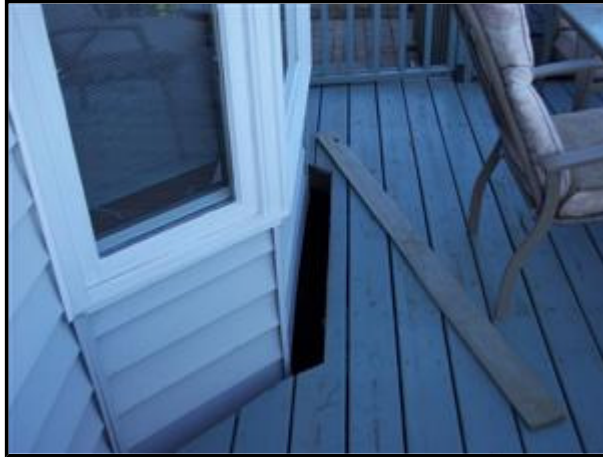
The large gap between the rear deck and the house (Picture 1 - next page) indicates that the deck has shifted on its footings. Observation below the deck reveals that the deck footings are placed on a slope and are beginning to fail (Picture 2 - next page). This could lead to complete collapse of the deck resulting in serious injuries. Consult immediately with a qualified contractor to reconstruct the deck with improved foundation support.

2.5 Picture 1 Gap between house and deck

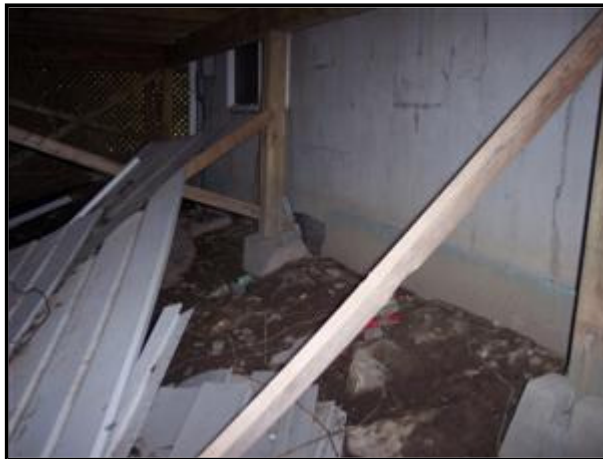
2.5 Picture 2 Foundation support for deck

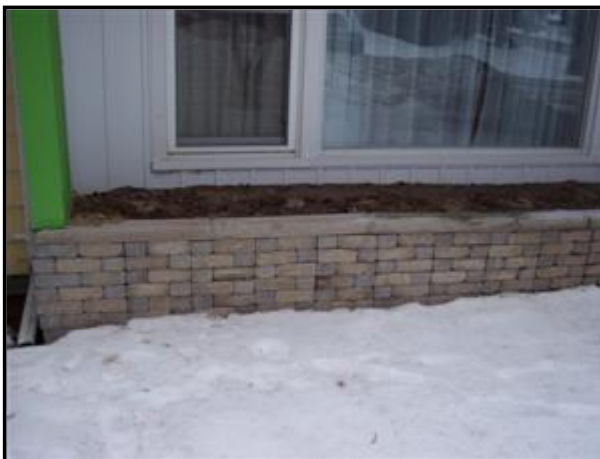
The front garden bed has been built up above the level of the foundation (Picture 1 - next page). This puts the wood frame wall structure at risk of water damage. Removal of the garden bed is required followed by further investigation of the condition of the wall behind it. Remove and replace any water damaged materials.

2.6 Picture 1 Garden bed at front

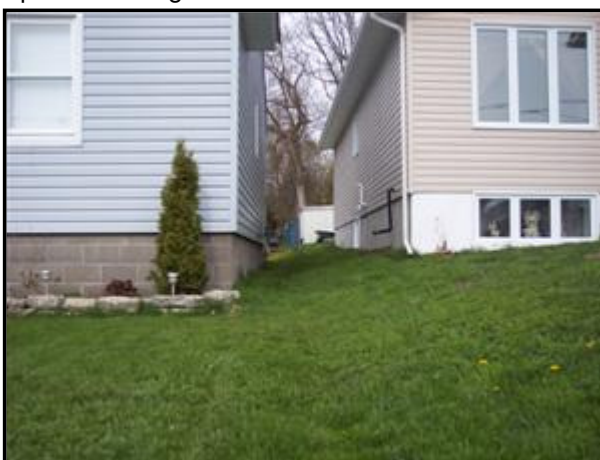
(2) The ground at the north side is sloped steeply toward the house (Picture 2 - below). This puts the basement at risk of water infiltration. Consult with a qualified landscaping contractor to adjust grade and improve drainage.

2.6 Picture 2 Grade at west side

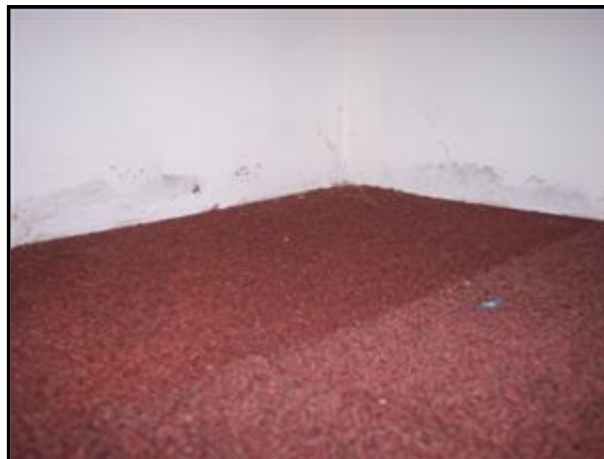
Water damaged drywall noted at NE corner. Remove and replace all water damaged material; extend downspout (item 1.3) and correct grading (item 2.6) at exterior to prevent further damage.

3.0 Picture 1 Water damaged drywall

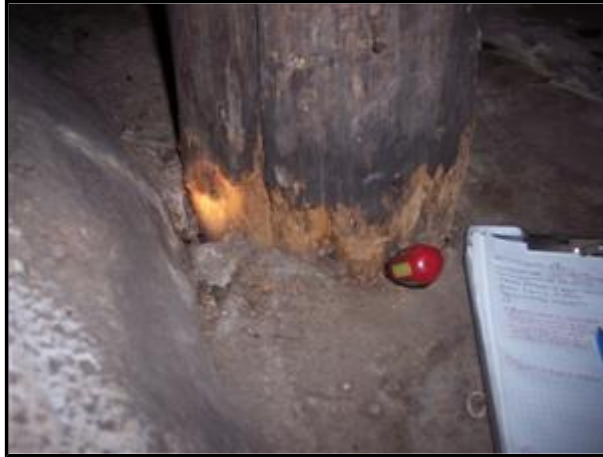
The wood column near the furnace has decayed due to wood/soil contact (Picture 1 - next page). Consult with a qualified contractor to replace this column within 2 years.

3.2 Picture 1 Wood column near furnace

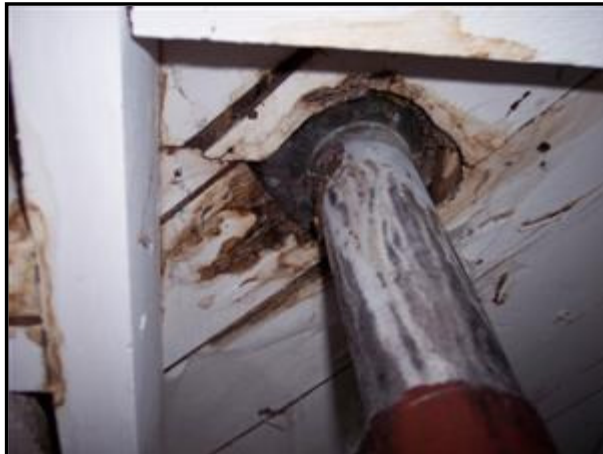
(1) The subfloor has been damaged by leakage from a poorly installed toilet on the main floor (Picture 1 - below). Consult with a qualified contractor to lift the toilet, repair the subfloor and re-install the toilet. See item 5.1.

3.3 Picture 1 Water damaged subfloor under toilet

Loose toilet (i.e. not properly fastened to floor) noted at main floor bath . This has allowed leakage of water in to the floor structure (see item 3.3). Consult with a licensed plumber to repair.

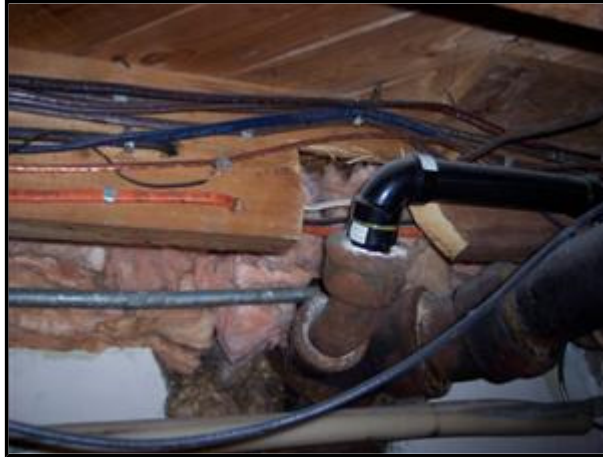
(2) A floor joist has been cut to accommodate a plumbing drain at the east side of the basement (Picture 2 - next page) and a joist is cracked just to the east of the furnace (Picture 3 - next page). Consult with a qualified contractor to assess and repair.

3.3 Picture 2 Damaged joist at east side of basement

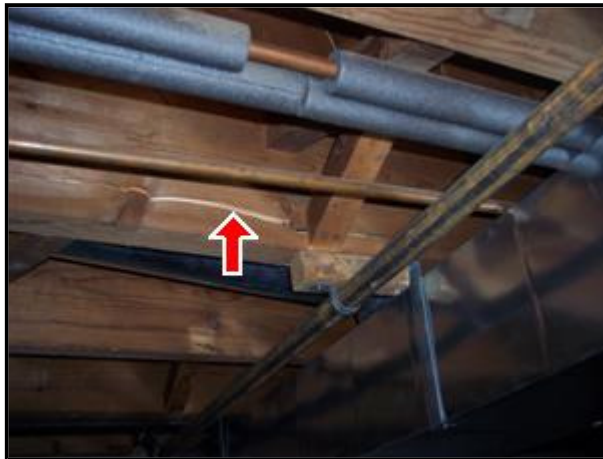
3.3 Picture 3 Cracked floor joist in basement

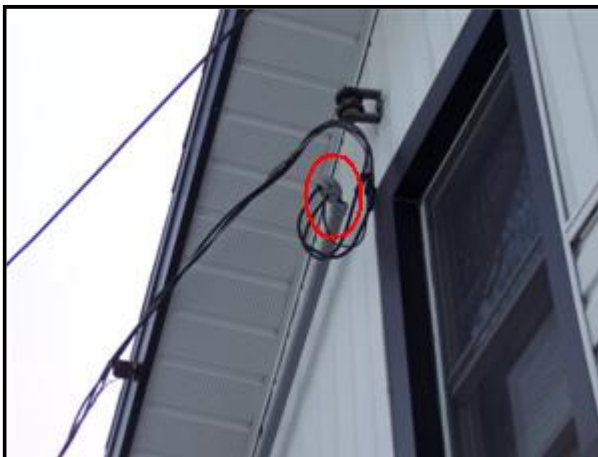
The electrical service mast is not properly clamped to the building (Picture 1), has sheared off at the entry point and shifted (causing strain on the service lines) - Picture 2 (next page). In addition, the weather head has separated from the mast potentially allowing water entry (Picture 1). Immediate repair by a licensed electrician is required.

6.0 Picture 1 Missing weather head and unclamped conduit

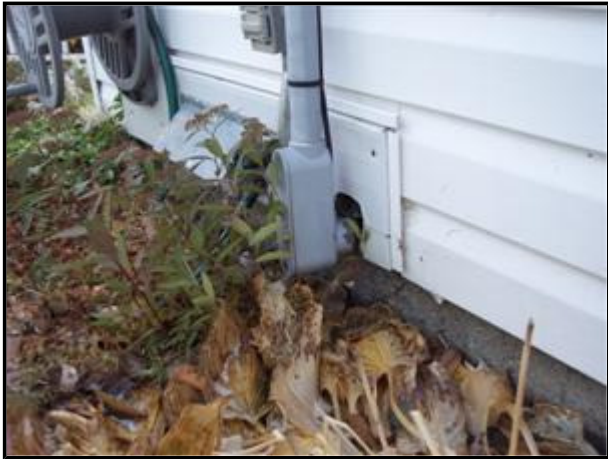
6.0 Picture 2 Broken conduit at service entry

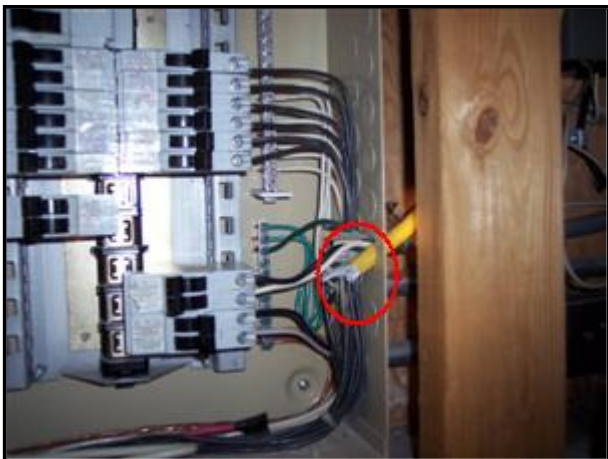
(1) The wire serving the dryer circuit is not clamped where it enters the main panel (Picture 1). Consult with a licensed electrician to repair.

6.1 Picture 1 Unclamped wire at main panel

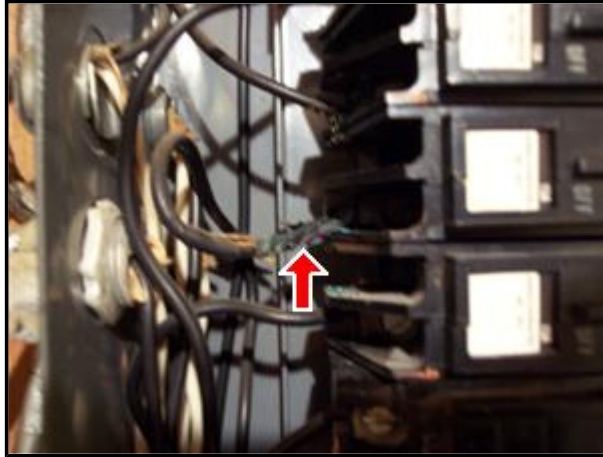
(2) One branch wire shows signs of overheating (melted insulation) in the electrical panel (Picture 2 - next page). Consult with a licensed electrician to assess and repair.

6.1 Picture 2 Branch circuit wire with melted insulation in electrical panel

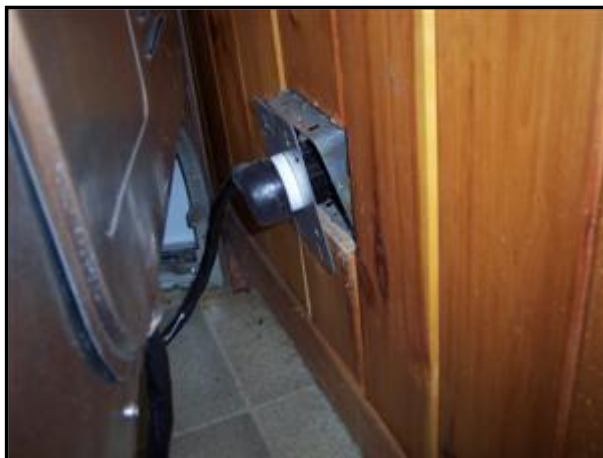
- The range outlet is not properly secured to the wall (Picture 1 - below).
- Unsafe junction at basement (West side) (Picture 2 - next page).
- Improperly terminated circuit above window at east side of basement (Picture 3 - next page).
- The exterior light fixture at the front door is not properly secured to the wall (Picture 4 - next page). This could allow rain-water to enter the electrical box.

6.3 Picture 1 Stove outlet

Consult with a licensed electrician to address the following items:

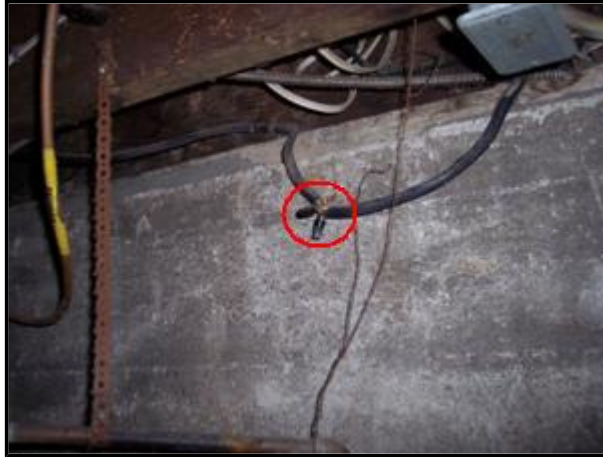
6.3 Picture 2 Unsafe junction at basement (west side)

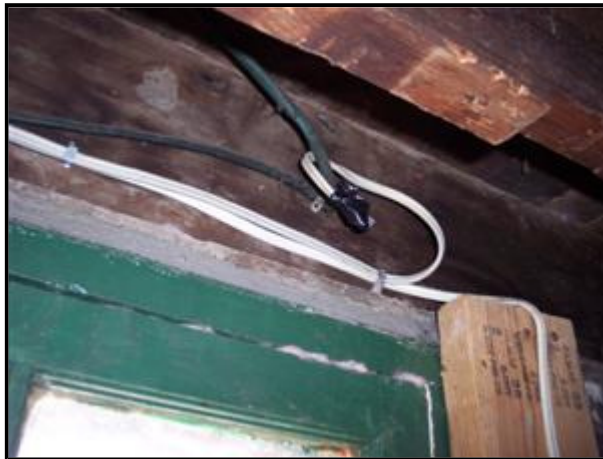
6.3 Picture 3 Improperly terminated circuit above basement east window

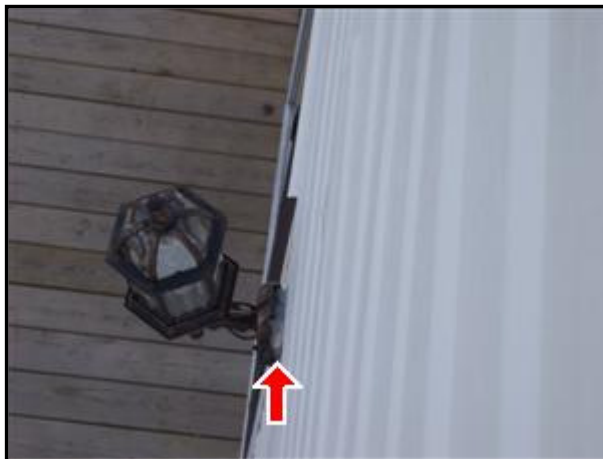
6.3 Picture 4 Exterior light fixture

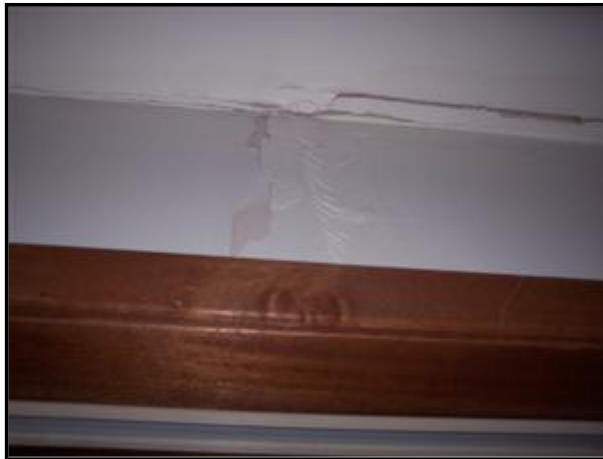
Water damage above living room window (Picture 1) is consistent with an ice dam. Read the attached article [Attic Venting, Attic Moisture and Ice Dams](#), remove all water damaged materials and consult with a qualified contractor reduce heat loss by air sealing and insulating the attic.

8.0 Picture 1 Water damage above living room window

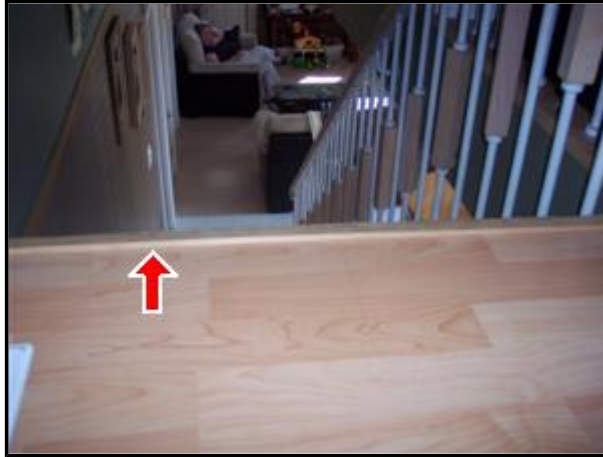
Trip hazard noted at top of main stairs (Picture 1 - next page). Consult with a qualified contractor to install a safer trim piece in this location.

8.3 Picture 1 Trip hazard at top of stairs

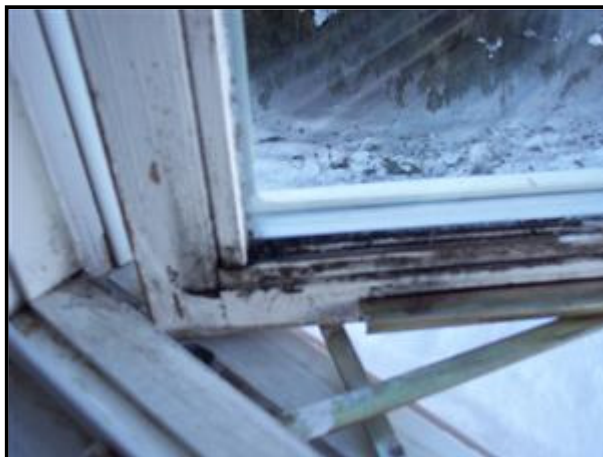
Mold and water damage noted at living room window (Picture 1 - below). Clean up mold with an appropriate cleaning solution, refinish wood.

8.6 Picture 1 Mold at living room window

Prevent further damage by reducing condensation:

- control humidity using exhaust fans (see [Moisture Problems](#));
- remove interior screens in winter;
- minimize the use of window coverings (curtains and blinds).

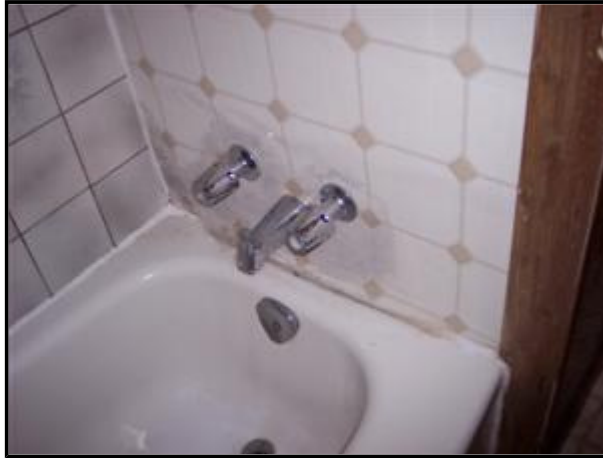
8.7 BATHROOMS
 (1) The tub surround is in very poor condition (Picture 1 - next page) and mold was noted on

8.7 Picture 1 Water damaged tub surround

the drywall behind the tub (Picture 2 - below). Consult with a qualified contractor to remove the tub and all water damaged materials and re-install tub with a new tub surround or tiles.

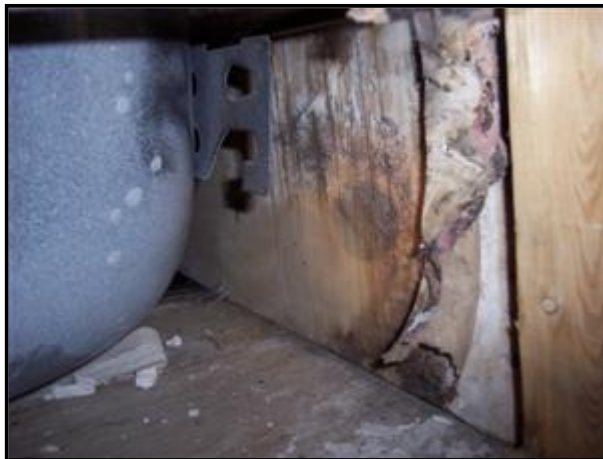
8.7 Picture 2 Moldy drywall behind tub

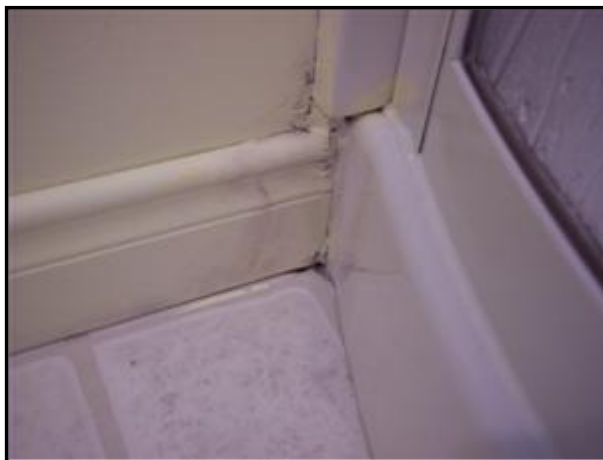
(2) Water staining was noted on the drywall and baseboard adjacent to the shower stall in the basement bathroom (Picture 3 - below). Consult with a qualified contractor to remove and replace all water damaged materials and to locate and repair the source of water.

8.7 Picture 3 Evidence of leakage at shower stall

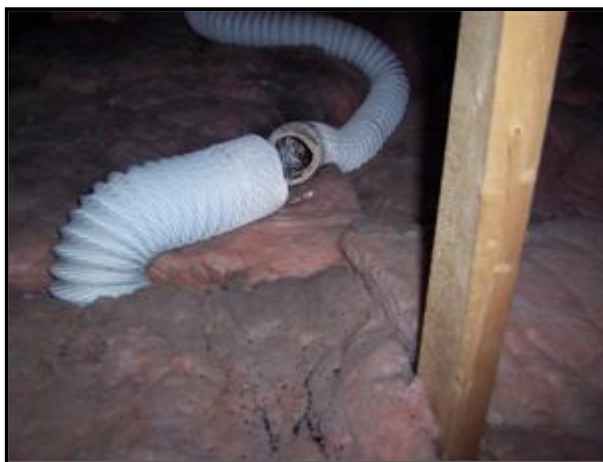
<input type="checkbox"/>	<input type="checkbox"/>	<input type="checkbox"/>	<input checked="" type="checkbox"/>	<input type="checkbox"/>	9.4 VENTING SYSTEMS (Kitchens, baths and laundry) House Ventilation: Exhaust fans at all bathrooms Dryer Power Source: 220 Electric Dryer Vent: Flexible Vinyl The bathroom exhaust fan duct is not connected in the attic (Picture 1). This allows warm, moist air to enter the attic, potentially causing moisture and mold problems in the attic. Consult with a qualified contractor to vent the bath fan to the exterior with a well sealed and insulated duct.

9.4 Picture 1 Bathroom exhaust fan duct in attic
